Certificate No: CBA-E24-1-S-B

Eaves (Insulation at ceiling level - inverted) Table K.1 Ref E24 Default ψ -value = 0.24 W/mK	Inner leaf	100 mm Blockwork
	Cavity	Partial cavity fill with low-e facing and 50mm cavity
	Outer leaf	102 mm Brick $\lambda = 0.77$
	Lintel	Folded steel with perforated baseplate
	Roof	Pitched roof over single storey addition with doorway. 150 mm of insulation with $\lambda = 0.037$ between 45mm wide joists. 250mm over joists

Calculated ψ -values and f -values for eaves (insulation at ceiling level – inverted) and cavity insulation as highlighted

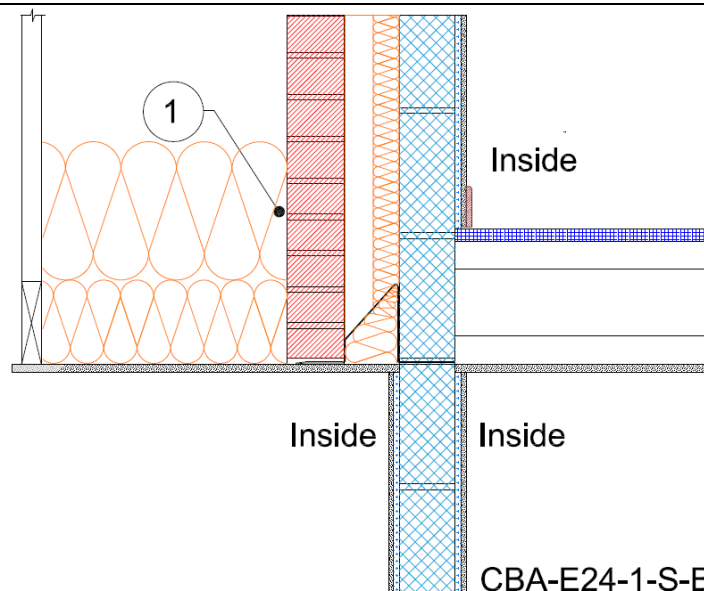
1. Ensure the roof insulation is tightly butted to the wall

1. Roof insulation is tightly butted to the wall
